# CYCLONE TESTING STATION

# **REPORT NO. TS1276**

# Serviceability and Cyclic Simulated Wind Load Strength Testing of Mitsubishi ALPOLIC NC Wall Cladding

# **Network Architectural Pty Ltd**

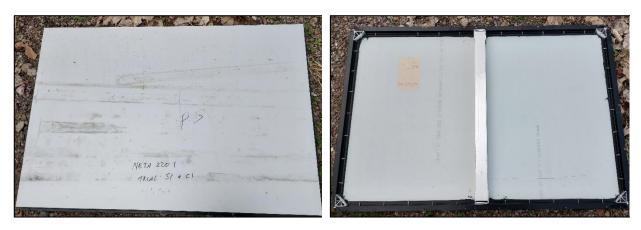
**Figure 1:** Photograph of *Mitsubishi ALPOLIC NC* cladding profile (note the 1,200 by 800 mm panel is displayed, larger panels have additional stiffeners)

The *Mitsubishi ALPOLIC NC* wall cladding panel was stated to have been made from two aluminium alloy outer skins of 0.5 mm thickness with a Lumiflon<sup>TM</sup> coating and 3 mm noncombustible core. The total thickness of the cladding panel was stated to be 4 mm. The panels have a flat surface and about 24 mm of the edges are folded 90° to form a tray. About 1.7 mm thick aluminium Z-sections (called Z-shaped flanges in this report) are screw fixed to the edge return using 10 gauge, 16 thread per inch, 20 mm long self-drilling stainless steel screws at 100 mm centres resulting in a nominal panel "thickness" of 30 mm. An aluminium corner extrusion was fixed to the ends of the Z-sections reinforcing the corners of the panel. Stiffeners made from square hollow section aluminium extrusions of dimensions  $50 \times 50 \times 3.5$  mm are fixed on the internal face of the panel trays using adhesive tape. The stiffeners run along the panels and their ends are fixed to the panel tray returns/Z-shaped flanges using 30 mm long  $40 \times 40 \times 3$  mm angles with 10 gauge, 16 thread per inch, 20 mm long self-drilling stainless steel screws. The size of the panels supplied were nominally  $4,000 \times 1,575$  mm,  $2,700 \times 800$  mm and  $1,200 \times 800$ . Figure 1 is photographs that show the cladding panel, Figure 2 the stiffeners and connection detail and Figure 3 the corner reinforcement detail.

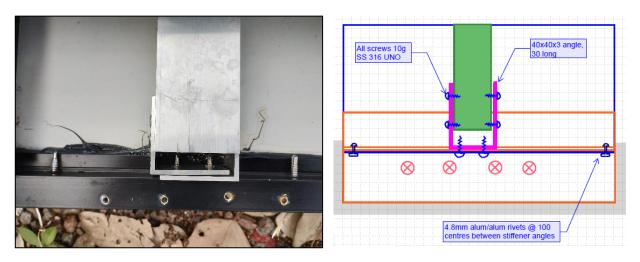
**Figure 2:** Photograph of panel stiffener and connection to the panel (left) and sketch, provided by the client, of the stiffener connection (right), note the rivets depicted in the sketch were replaced with screws

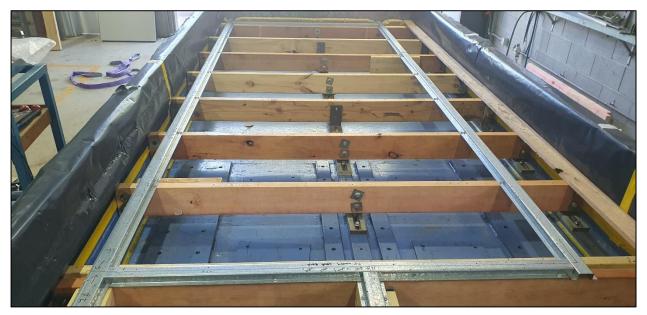
Figure 4: Top hat substructure fixed to timber purlins for one panel

The wall cladding panels were screw fixed to a substructure made from continuous sections of Rondo 1.15 mm Base Metal Thickness (BMT) top hat battens. The top hats were fixed to MGP12 structural timber purlins at nominally 600 mm centres. Figure 4 shows a photograph of a the top hat substructure fixed to timber purlins spaced at 600 mm.

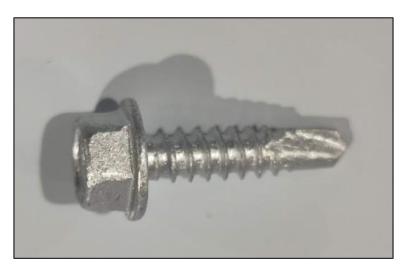
Figure 5:  $10-16 \times 20$  mm self-drilling stainless steel screw used to fix the panels to the top hat batten substructure

The Z-shaped flanges attached to the panels were screw fixed to the top hat battens using 10-gauge, 16 thread per inch self-drilling stainless steel screws with a length of 20 mm. Figure 5 shows a photograph of a typical stainless steel 10 gauge.

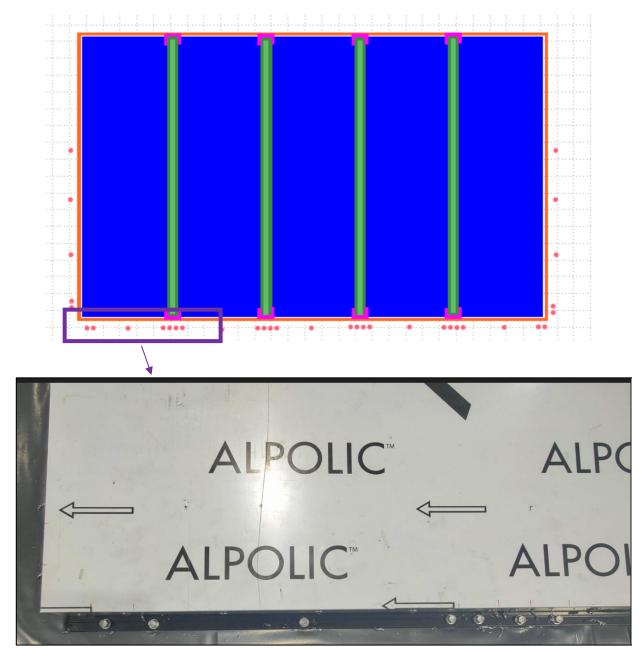
Figure 6: Sketch of perimeter fixing locations, provided by the client (upper) and detailed view of perimeter fixings (lower)

The panel system was fixed to the supports using four fasteners at positions adjacent the stiffeners and two fasteners at the corners. An additional fastener was positioned midway between stiffeners. Figure 6 is a sketch, provided by the client, and photograph of the panel fixing detail.

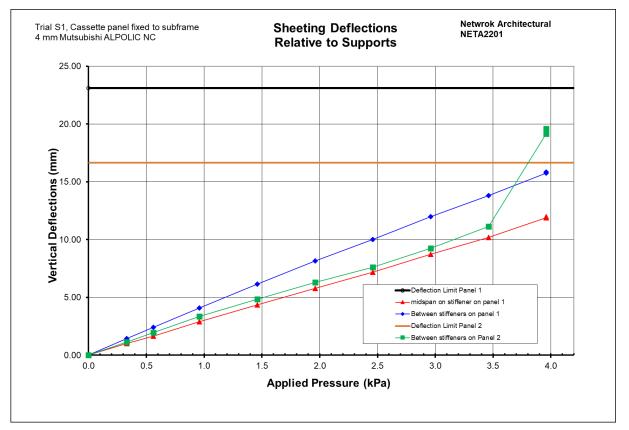
Figure 7: Plots of cladding deflections relative to supports (Trial S1)

One wind load serviceability test was performed. The results of the serviceability tests are summarised in Table 3; all stated deflections are relative to the deflections measured on top of the screws at the supports and the deflections measured under load are stated to the nearest 0.05 mm, while the residual deflections are stated to the nearest 0.01 mm. All serviceability tests were terminated when the cladding showed first signs of permanent deformation, or the deflection limit was reached for either panel. Plots of the deflections relative to the supports are presented in Appendix A.

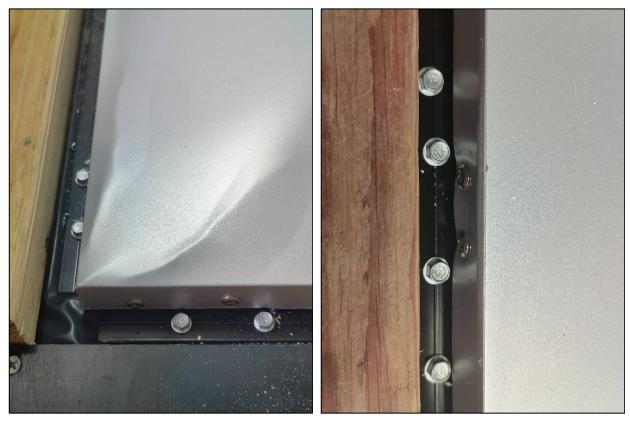
Figure 8: Typical deformation to panel skin in corner (left) and along edges (right)

One cyclic simulated wind load strength test was performed. A summary of the test results and observations is provided in Table 5. For photographs of damage and failure see Appendix B.

Trial No.	Date Tested	Test Pressure P <sub>t</sub> (kPa)	Ultimate Load Applied (kPa)	Results and Observations
C1	18 Jan 2023	6.14	7.98	<b>Pass</b> . Creasing in corners of panel 1. Panel skin had separated from stiffeners (tape no longer holding).

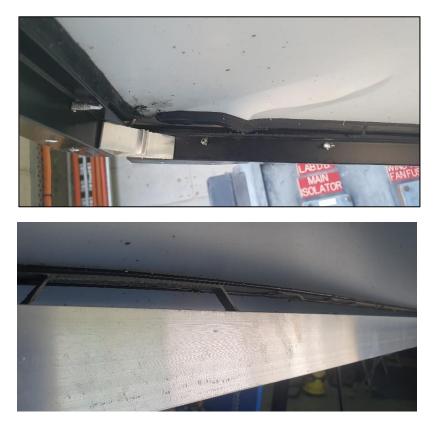
Figure 9: Typical deformation of skin viewed from underside of panel (upper) and view of detachment of stiffeners from underside of panel (lower)
